**DEPARTMENT OF TRANSPORTATION**

Contract #: 04-0120F4Cty: SF/ALA Rte: 80 PM: 13.2/13.9File #: 69.28**WELDING INSPECTION REPORT****Resident Engineer:**Pursell, Gary**Address:** 333 Burma Road**City:** Oakland, CA 94607**Report No:** WIR-015695**Date Inspected:** 19-Jul-2010**Project Name:** SAS Superstructure**OSM Arrival Time:** 700**Prime Contractor:** American Bridge/Fluor Enterprises, a JV**OSM Departure Time:** 1900**Contractor:** Zhenhua Port Machinery Company, Ltd (ZPMC), Changxing Island **Location:** Shanghai, China**CWI Name:** Li Yang and Zhu Zhong Hai**CWI Present:** Yes No**Inspected CWI report:** Yes No N/A**Rod Oven in Use:** Yes No N/A**Electrode to specification:** Yes No N/A**Weld Procedures Followed:** Yes No N/A**Qualified Welders:** Yes No N/A**Verified Joint Fit-up:** Yes No N/A**Approved Drawings:** Yes No N/A**Approved WPS:** Yes No N/A**Delayed / Cancelled:** Yes No N/A**Bridge No:** 34-0006**Component:** OBG Trial Assembly**Summary of Items Observed:**

Orthotropic Box Girder (OBG) Trial Assembly Areas

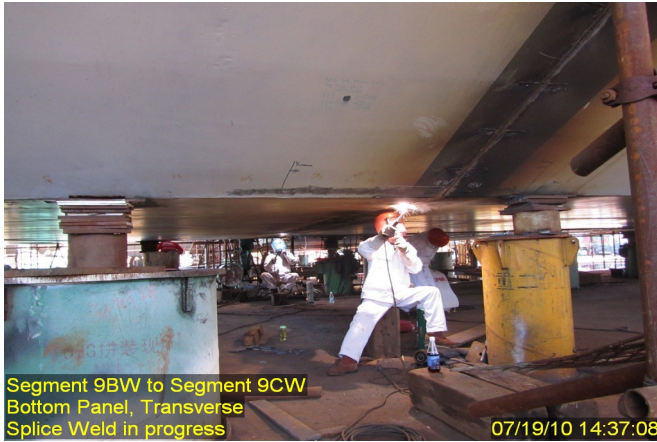
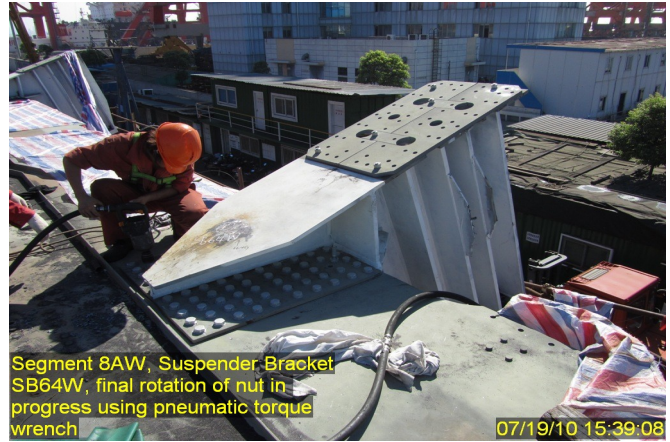
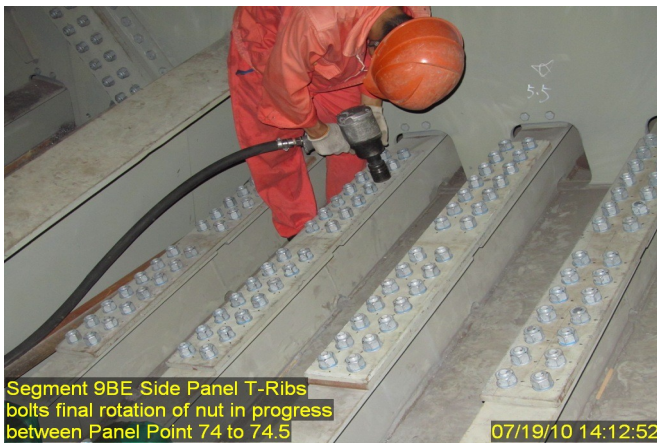
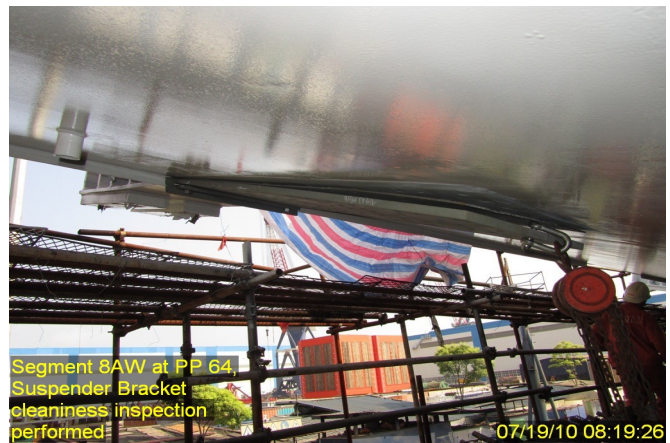
This QA Inspector observed the in-process welding by Shielded Metal Arc Welding (SMAW) process on a Complete Joint Penetration (CJP) groove weld. The Weld joint was designated as OBW9B-008. The welder identification was 066326 and 045196 and was observed welding in the 4G (Overhead) position using approved Welding Procedure Specification WPS-B-P-2214-B-U2-FCM-1. The Piece Mark was identified as the Bottom Panel transverse splice weld. Please reference the pictures attached for more comprehensive details.

This QA Inspector observed that the ZPMC personnel was performing final rotation of nut after snug tightening by pneumatic torque wrench, for the bolts installed at Side Panel T-Ribs for Segment 9BE between Panel Points (PP) 74 and PP 74.5 Cross Beam side. Please reference the pictures attached for more comprehensive details.
